# Manhole Inspection Summary

Manhole # S51M\_\_025MH

Insp Date: **4/4/08 10:59 AM**

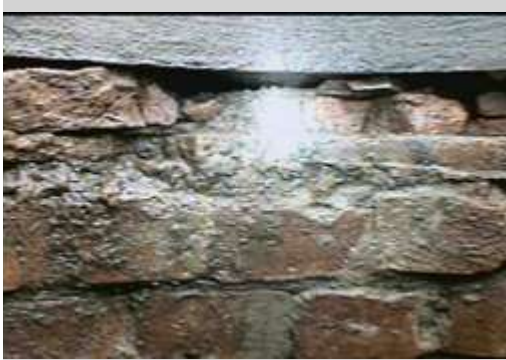
Defect 2

Condition: ☐ Sound ☐ Cracked ☐ Root Intrusion ☒ **Loose Brick** ☒ **Deteriorated**

Infiltration: ☐ None ☐ Joint ☐ Cracks ☐ Mortar ☐ Roots ☒ **Wall**

Loose Bricks, Deterioration and Infiltration in Chimney

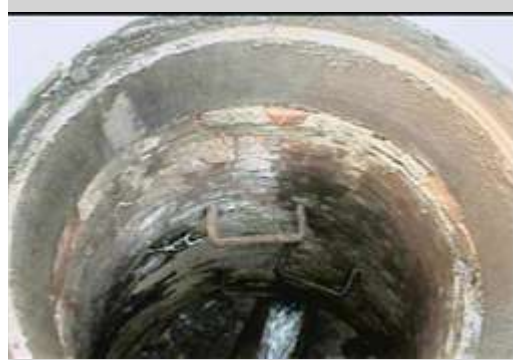
Defect 1

Count: **3** Missing: **0** ☒ **Corroded**

steps

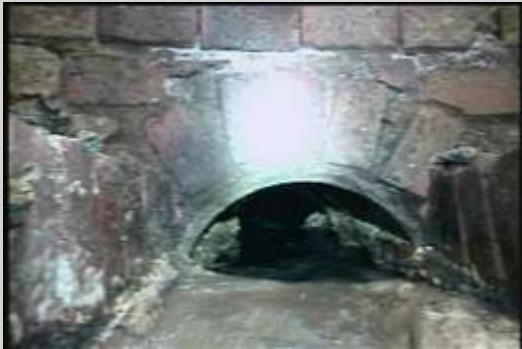
12 O'Clock Outflow

8 in. Circular Gravity Sewer  
Pipe Out @ 12 O'Clock

Invert Depth: **8.16** (ft.) Flow Characteristics: **Slow**

Infiltration: **None** Pipe Seal Cond: **Unknown**

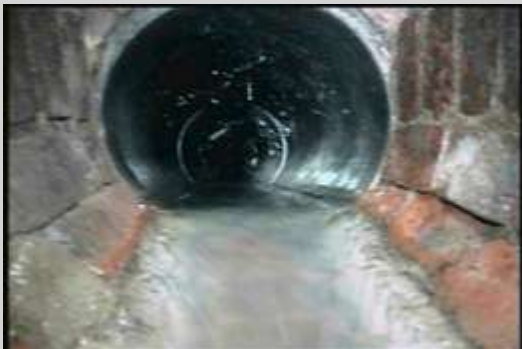
3 O'Clock Inflow

8 in. Circular Gravity Sewer  
Pipe In @ 3 O'Clock

Invert Depth: **7.70** (ft.) Flow Characteristics: **Slow**

Infiltration: **None** Pipe Seal Cond: **Unknown**

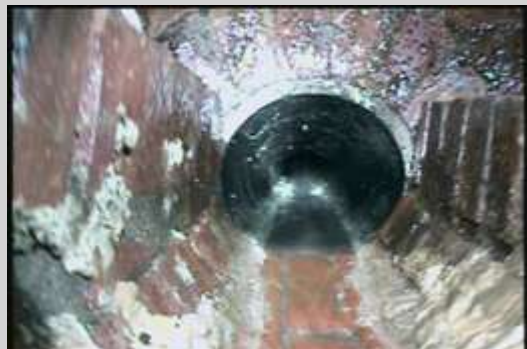
6 O'Clock Inflow

8 in. Circular Gravity Sewer  
Pipe In @ 6 O'Clock

Invert Depth: **7.66** (ft.) Flow Characteristics: **Slow**

Infiltration: **None** Pipe Seal Cond: **Unknown**
